BRICK, BLOCK & BEERS

MASONRY ASSOCIATION OF FLORIDA | VOLUME II, ISSUE II JUNE 2018

Masonry Best Practices : Control Joints for Concrete Masonry Walls

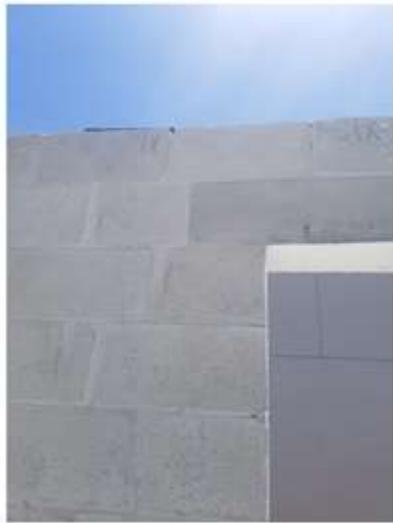
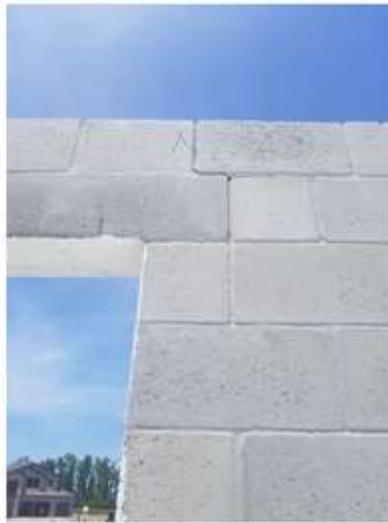
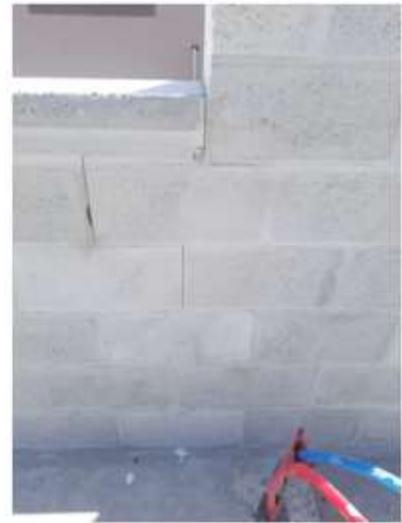
The photos above show residential structures with cracking at the corners of significant openings (over 6 ft). First, is this cracking "normal" or is there a material defect? Secondly, is this a structural problem for the home? Third, what is the recommended repair?

The pictures provided show cracks under the precast header bearing at what appears to be both ends of an opening. These cracks then turn and extend up to the top of the wall through the course above the precast in a stair step fashion. The third picture provided shows cracking under the end of a precast sill which then extends from the lower right hand corner of the open'g down the wall in a stair step fashion.

The pictures provided are so indicative of classic masonry shrinkage cracking that I intend to catalog and use them in future presentations to show where cracking usually shows up in structures where shrinkage of the masonry has not been addressed by either horizontal reinforcing or properly placed control joints.

cracking to occur is at the corners of openings. The reason is that mother nature views a section of the wall where a large part has been removed (you know - like an opening) as the perfect place to "joint" the wall. Recommended practices at openings thus calls for a control joint to be created adjacent to openings (almost exactly as mother nature has positioned these). As an alternative to control jointing at opening corners the steel over and under the opening can be extended into the adjacent wall sections, usually by around 24 inches.

My take on the cracks shown in the pictures is that they are permanent control joints in the structure. As long as the horizontal and vertical steel required by the designer is in place I would expect them to cause no significant detrimental effect on the structural capacity of the wall.

They are now your control joints, picked by mother nature herself, and repair would be to simply treat them as such. They should be routed out and stuffed with a backer rod then caulked with a one part polyurethane sealant and painted over (just the joint area - not the entire wall) with an elastomeric.
